Mirror surface quality before and after coating

This document describes the influence of coating to the mirror surface quality.

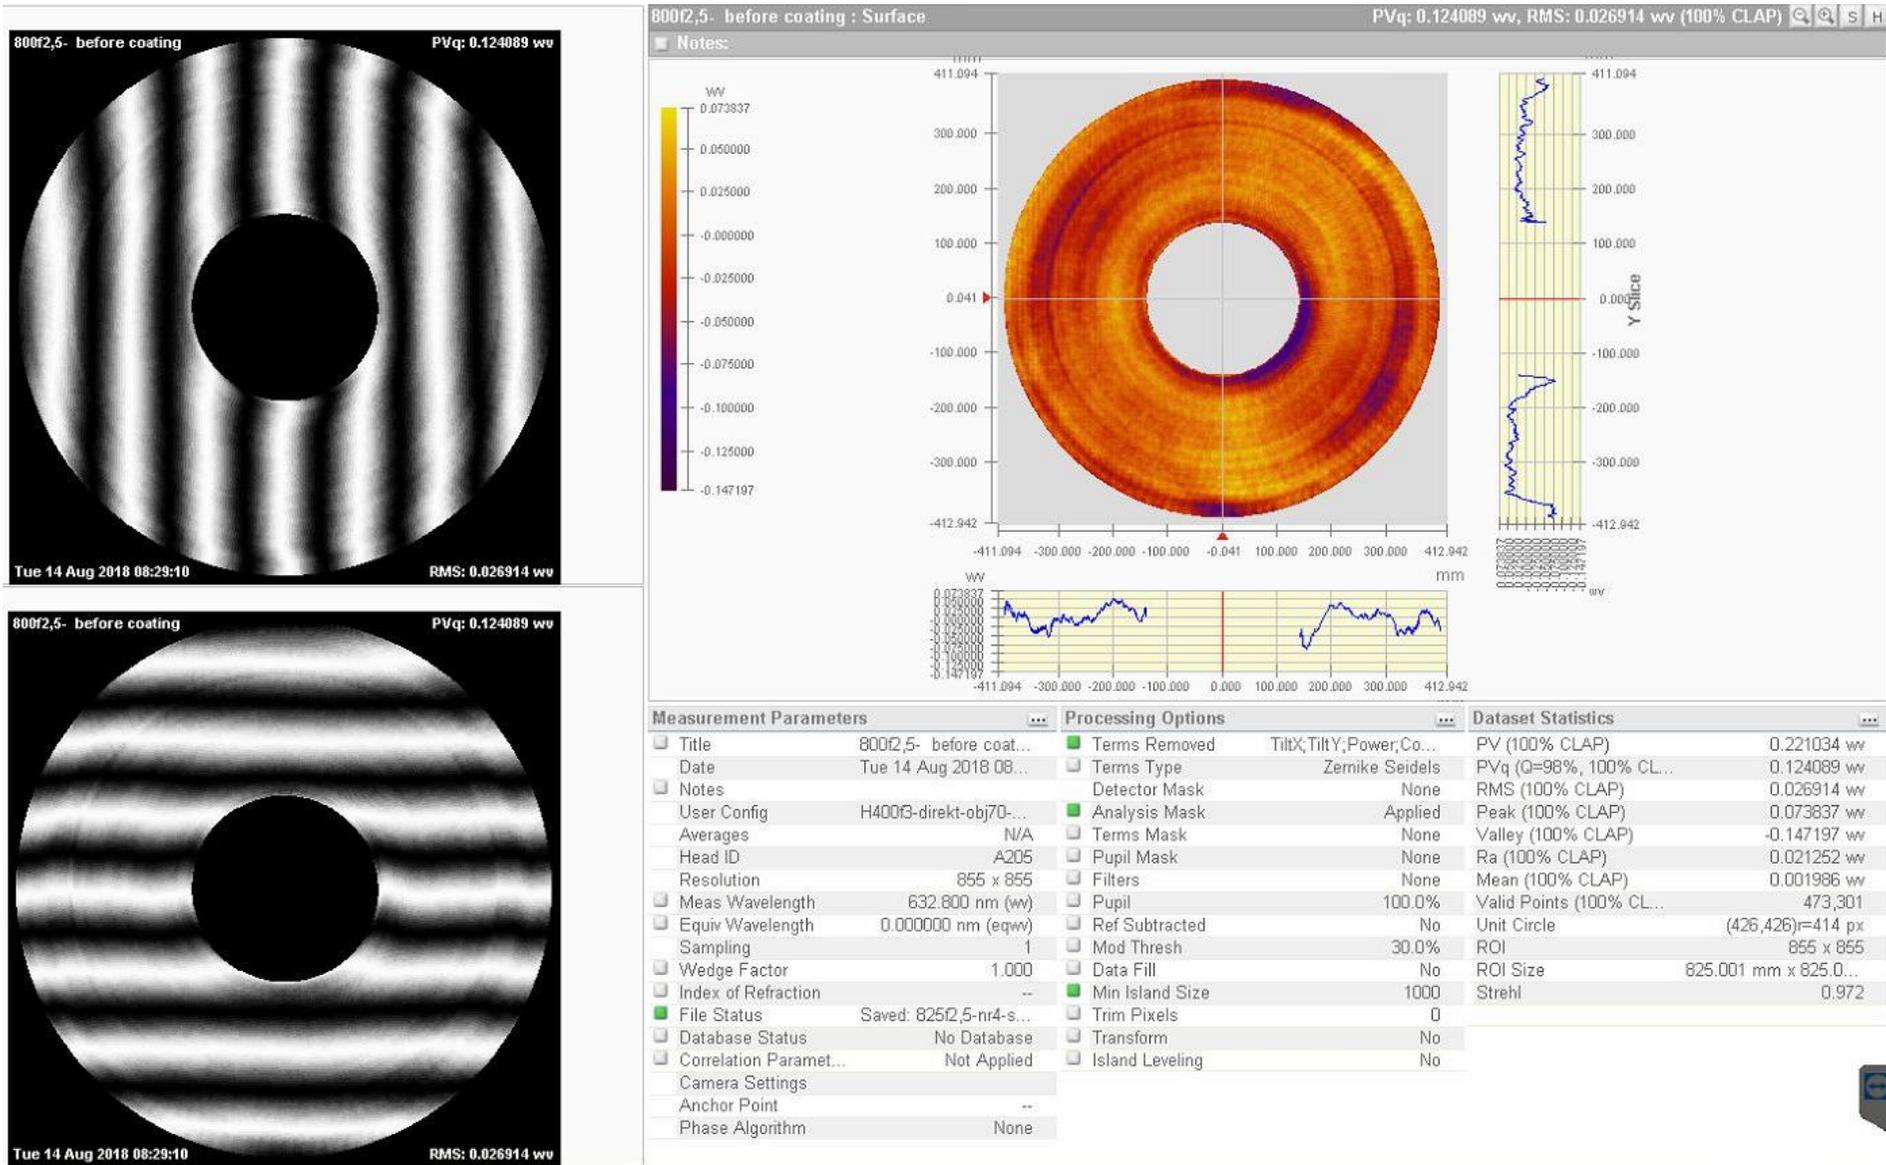
2 Before Coating

The following example shows the interferograms of an 800mm f2.5 RC primary mirror measured before and after coating.

When we compared measurements before coating against the measurements after coating, we could never find any reproducible errors that could be assigned with coating and where larger than our measurement error.

The results in the example here show a typical minor change that can as well be attributed to simple random measurement errors.
